**Flood Control Project Maintenance
Levee Inspections**

Fall 2013 Levee Maintenance Deficiency Summary Report

San Joaquin River Basin

Reclamation District No. 2062 Stewart

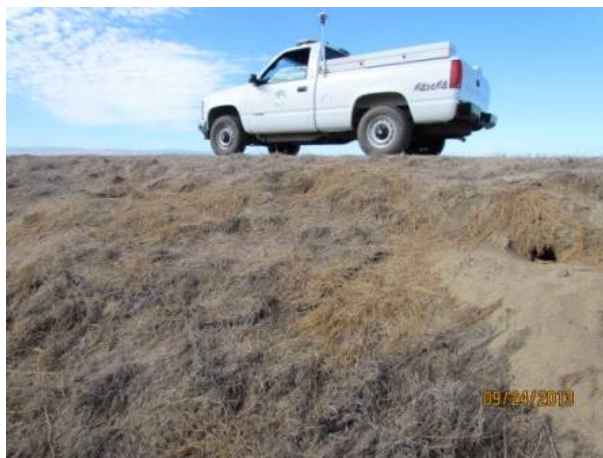
View of the animal burrows in the waterside levee slope.

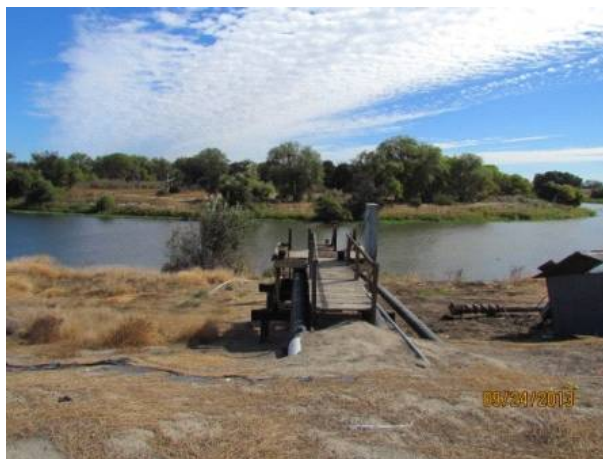
Levee Mile Report Line	11
Start Levee Mile	1.67
End Levee Mile	1.67
Location	Water Side
Category	Earthen Levee
Item	Encroachments

View of the pipe penetrating the waterside levee slope.

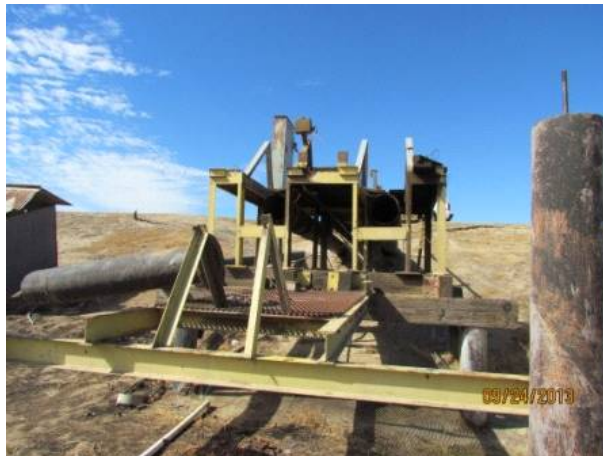
Levee Mile Report Line	11
Start Levee Mile	1.67
End Levee Mile	1.67
Location	Water Side
Category	Earthen Levee
Item	Encroachments

View of the open pipes without a positive closure device installed.

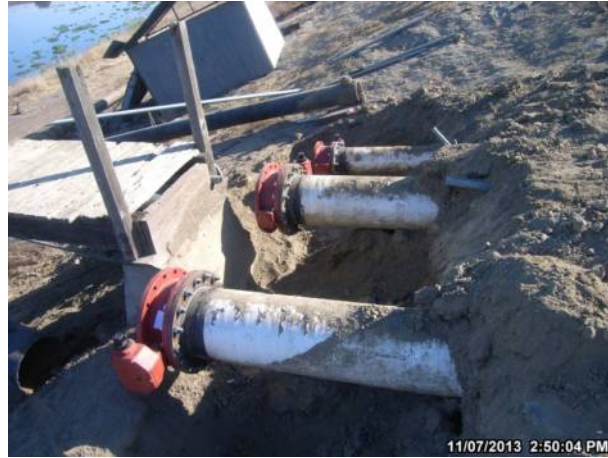
View of the pipes with positive closure devices installed.

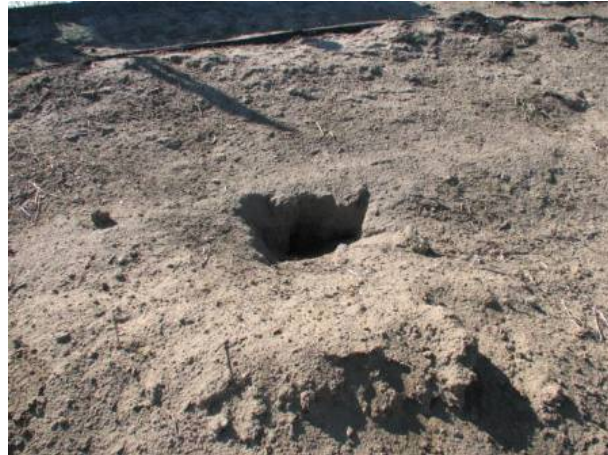
Levee Mile Report Line	12
Start Levee Mile	1.83
End Levee Mile	1.83
Location	Water Side
Category	Earthen Levee
Item	Animal Control

10/20/2011 Large burrow located on waterside slope of levee.

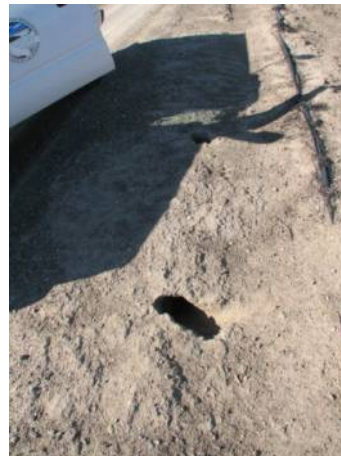
Levee Mile Report Line	12
Start Levee Mile	1.83
End Levee Mile	1.83
Location	Water Side
Category	Earthen Levee
Item	Animal Control

10/20/2011 Large burrow located near crown on waterside slope of levee.

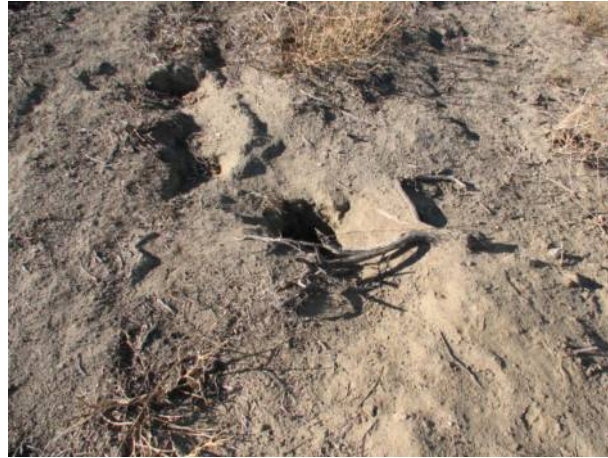
Levee Mile Report Line	12
Start Levee Mile	1.83
End Levee Mile	1.83
Location	Water Side
Category	Earthen Levee
Item	Animal Control
10/20/2011 Large burrow located on waterside slope of levee.	
mkhashch_f_20130923_243.jpg

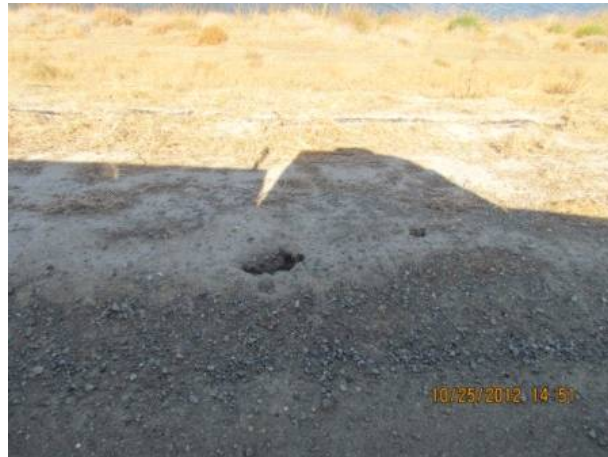
Levee Mile Report Line	12
Start Levee Mile	1.83
End Levee Mile	1.83
Location	Water Side
Category	Earthen Levee
Item	Animal Control
View of large burrow on waterside slope.	
mkhashch_f_20130923_244.JPG

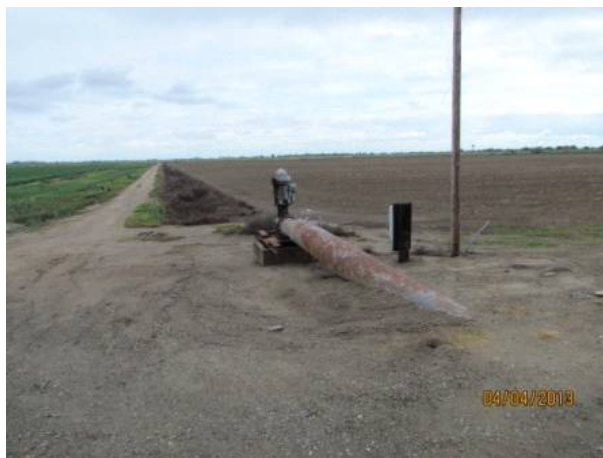
View of the pipe daylighting at the landside levee toe.

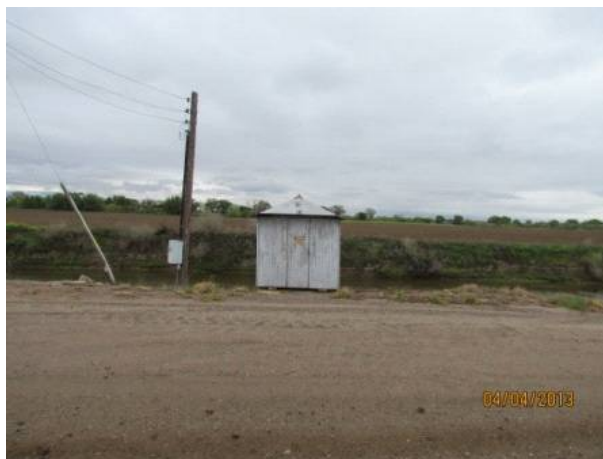
Levee Mile Report Line	3
Start Levee Mile	0.76
End Levee Mile	0.76
Location	Water Side
Category	Earthen Levee
Item	Encroachments

View of the pump house at the waterside levee hinge.

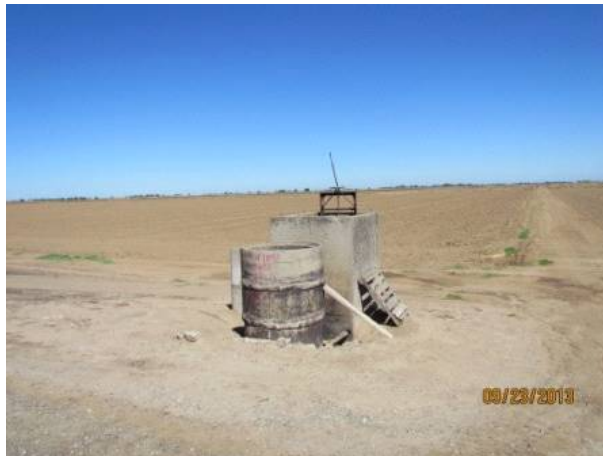
Levee Mile Report Line	3
Start Levee Mile	0.76
End Levee Mile	0.76
Location	Water Side
Category	Earthen Levee
Item	Encroachments

View of the standpipe and slide gate at the landside levee slope.

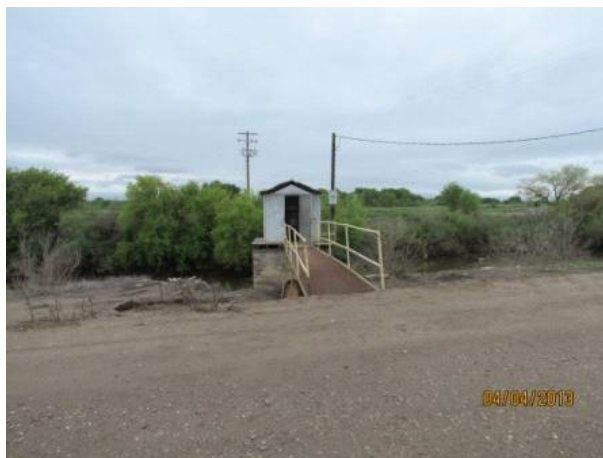
View of the pump house at the waterside levee hinge.

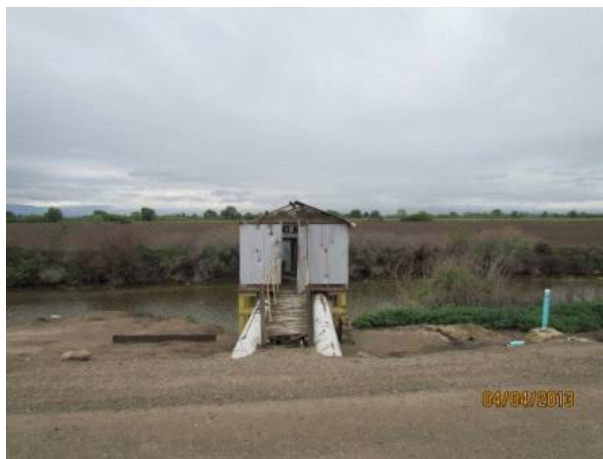
Levee Mile Report Line	5
Start Levee Mile	1.67
End Levee Mile	1.67
Location	Water Side
Category	Earthen Levee
Item	Encroachments

View of the pump house at the waterside levee hinge.

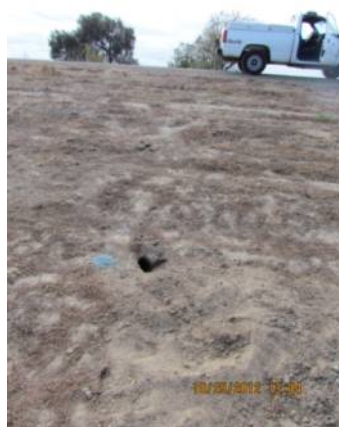
Levee Mile Report Line	6
Start Levee Mile	2.04
End Levee Mile	2.04
Location	Land Side
Category	Earthen Levee
Item	Animal Control

View of bait next to active burrow on landside slope.

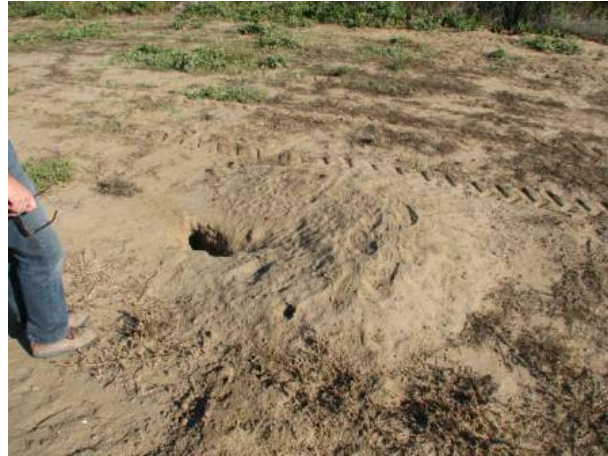
Levee Mile Report Line	7
Start Levee Mile	2.10
End Levee Mile	2.10
Location	Land Side
Category	Earthen Levee
Item	Animal Control
10/20/2011 Photo shows single large burrow, which appears to be active.	
mkhashch_f_20130923_263.jpg

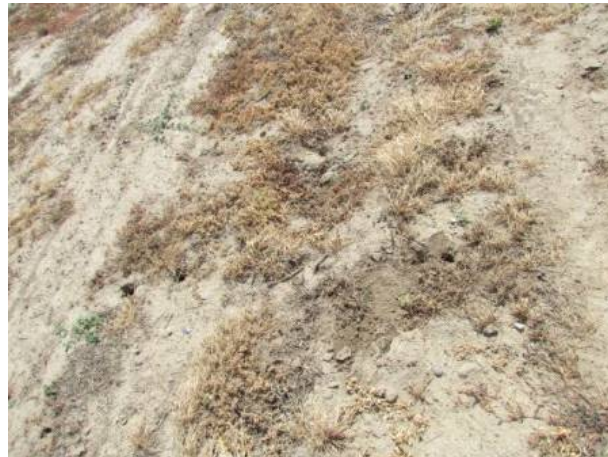
Levee Mile Report Line	7
Start Levee Mile	2.10
End Levee Mile	2.10
Location	Land Side
Category	Earthen Levee
Item	Animal Control
View of multiple burrow holes; the previously large burrow hole was not found at the time, but rodent activity is still present. 05/17/2012	
mkhashch_f_20130923_264.jpg

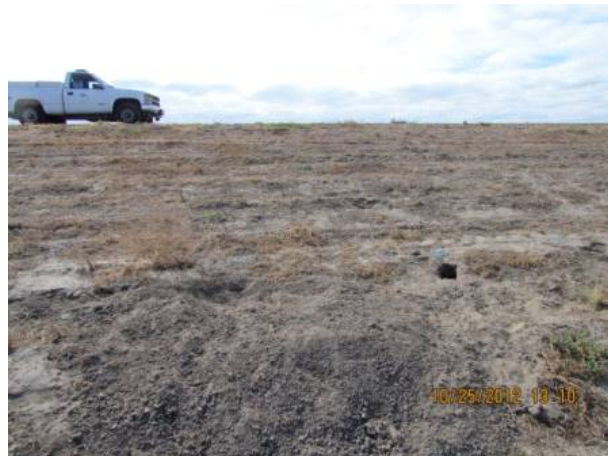
Levee Mile Report Line	7
Start Levee Mile	2.10
End Levee Mile	2.10
Location	Land Side
Category	Earthen Levee
Item	Animal Control
View of active burrows on landside slope.	
mkhashch_f_20130923_265.JPG

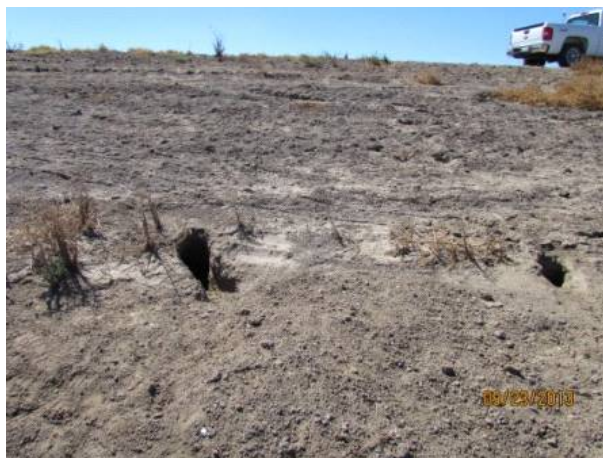
View of animal burrows on landside levee slope.

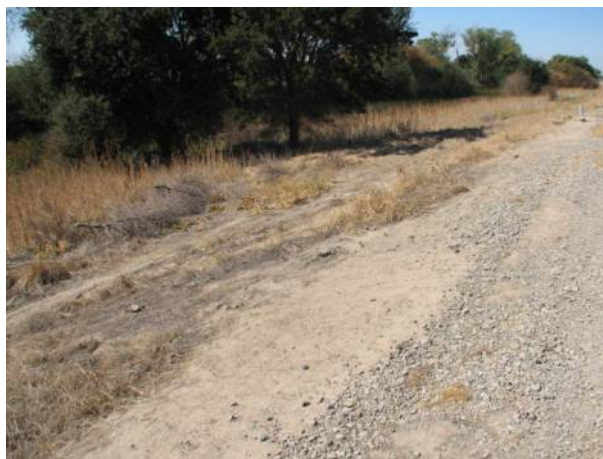
Levee Mile Report Line	12
Start Levee Mile	2.89
End Levee Mile	2.89
Location	Water Side
Category	Earthen Levee
Item	Trim / Thin Trees

Three small stumps on levee slope.

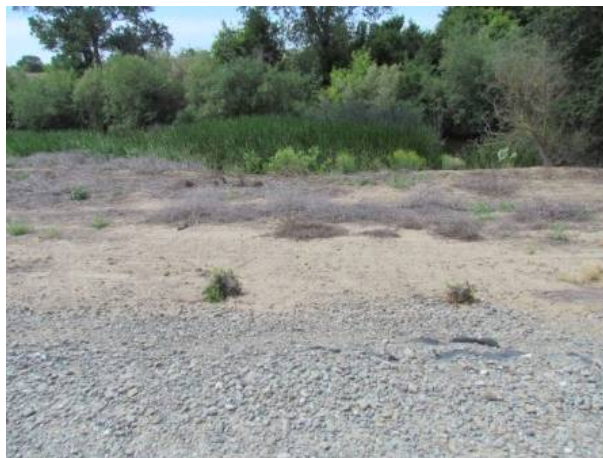
Levee Mile Report Line	13
Start Levee Mile	2.94
End Levee Mile	2.94
Location	Water Side
Category	Earthen Levee
Item	Trim / Thin Trees

View of tree stumps on waterside slope.
05/17/2012

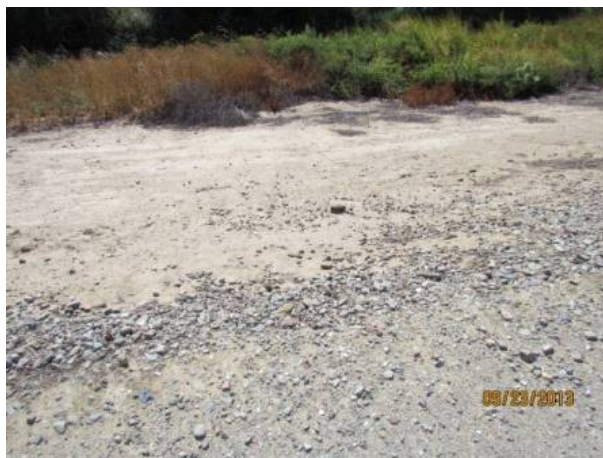
View of the tree stump in the middle of the photo.

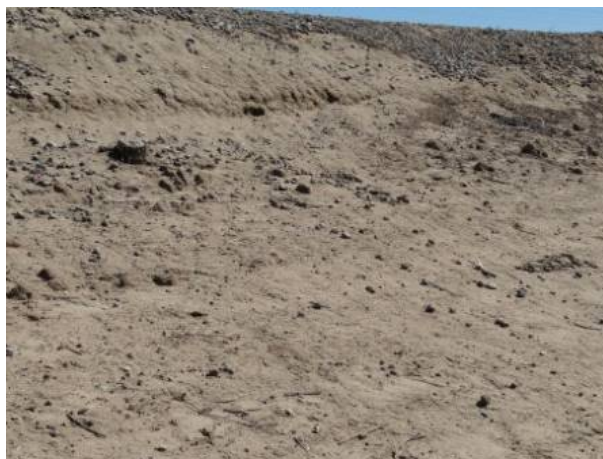
Levee Mile Report Line	17
Start Levee Mile	3.27
End Levee Mile	3.28
Location	Water Side
Category	Supplemental
Item	DWR Erosion Survey

17	3.27	3.28	Supplemental	DWR Erosion Survey	WS	M Ma	Inspector Comments: 08/28/2013: No significant change observed. 07/26/2012: Site was visited on 07/26/2012. No significant changes observed. 09/02/2011: No significant changes observed on site from last visit. 09/22/2010: No significant changes observed on site. The fencing located on the berm was removed. Levee slope and berm area 10 feet from the levee toe are bare of any vegetation. The 1- to 2 feet of near-vertical scarp on the levee toe is unchanged. 03/09/2010: As discussed with Michael Moncrief of MBK Engineer, the district will address the site this year. 7/27/2009: 1 to 2 feet of near-vertical scarp on the levee toe; damage was most likely caused by agricultural equipment during clearing or tilling operation; this is a maintenance-related issue. [2013 Site ID:RD2062U02RM2.14]	37.804604 ° -121.379454 °	37.804604 ° -121.379454 °	1 Y

Close view of scarp.

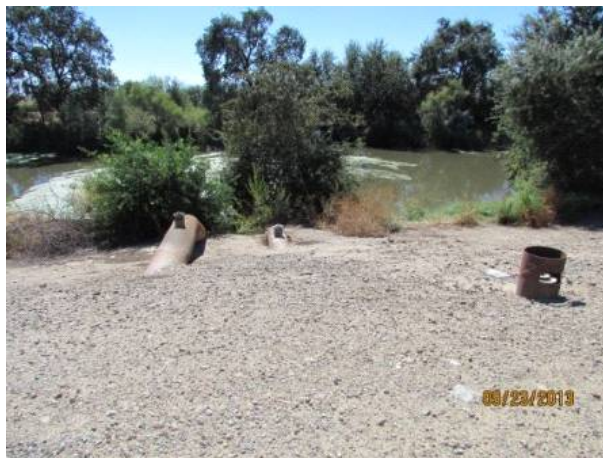
Levee Mile Report Line	18
Start Levee Mile	3.30
End Levee Mile	3.30
Location	Land Side
Category	Earthen Levee
Item	Encroachments

View of the pipes on the waterside levee slope.

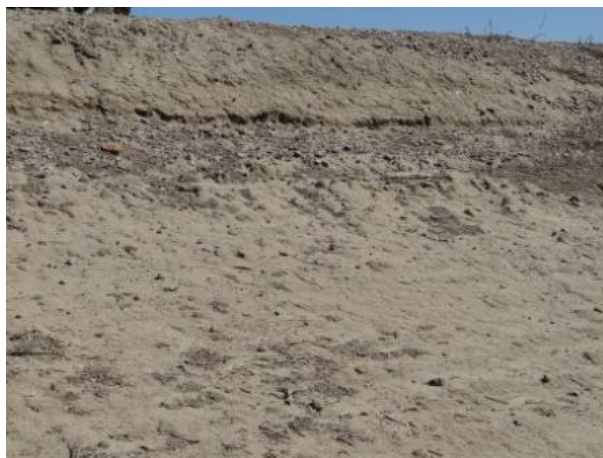
LMR No.	Levee Mile		Category	Item	Location *	Rating ** +	Action/Comment	GPS Latitude/Longitude		Issue No. Photo
	Start	End						Start	End	
19	3.44	3.53	Supplemental	DWR Erosion Survey	WS	M Ma	Inspector Comments: 08/28/2013: No significant change observed. 07/31/2012: Site was visited on 07/26/2012. No significant change observed. 09/02/2011: No significant change observed. 09/22/2010: No significant changes observed. The foot-high near-vertical scarp still exists on levee toe. There is little to no vegetation on the slope. 03/09/2010: As discussed with Michael Moncrief of MBK, site will be addressed this year. 07/27/2009: 1 to 2 feet of near-vertical scarp on levee toe; damage was most likely caused by farming equipment during clearing or tilling operation; this is a maintenance-related issue. [2013 Site ID:RD2062U02RM1.94]	37.805422 ° -121.383173 °	37.805422 ° -121.383173 °	2 Y
DWR ID:

Front view of site.

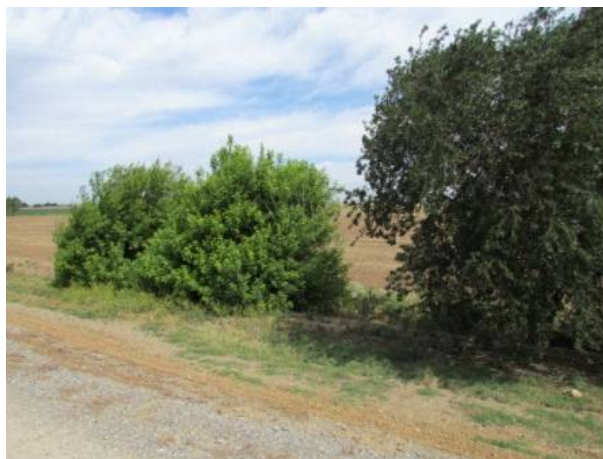
Levee Mile Report Line	20
Start Levee Mile	3.45
End Levee Mile	3.45
Location	Land Side
Category	Earthen Levee
Item	Trim / Thin Trees

View of bushy trees at levee toe obstructing visibility. 05/17/2012

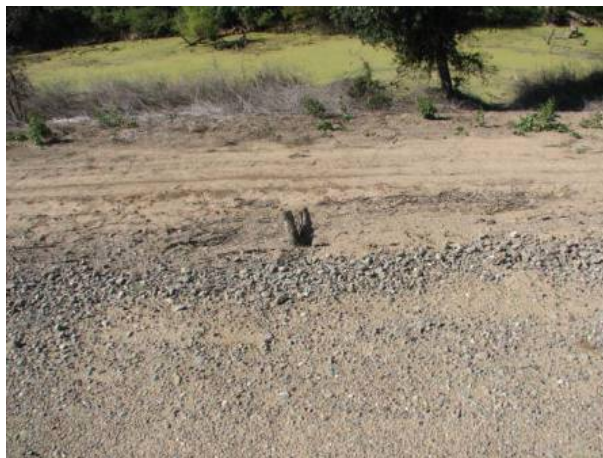
Levee Mile Report Line	21
Start Levee Mile	3.68
End Levee Mile	3.68
Location	Water Side
Category	Earthen Levee
Item	Trim / Thin Trees

05/11/2011 Small stump in waterside slope.

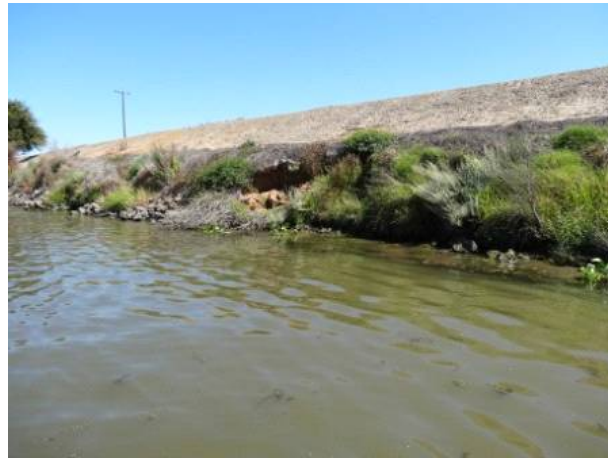
Looking from downstream.

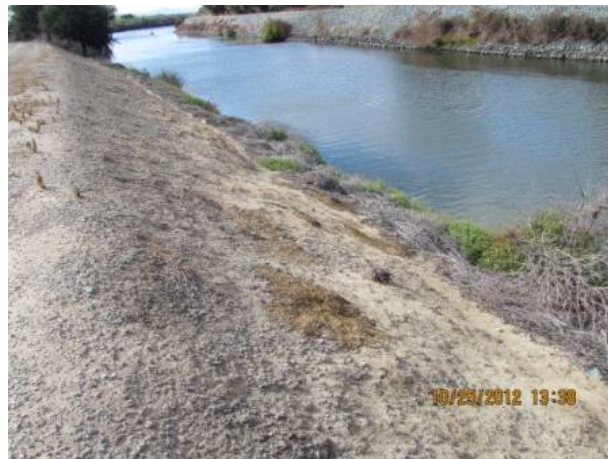
Levee Mile Report Line	2
Start Levee Mile	0.08
End Levee Mile	0.08
Location	Water Side
Category	Earthen Levee
Item	Trim / Thin Trees

View of tree stumps on waterside slope.

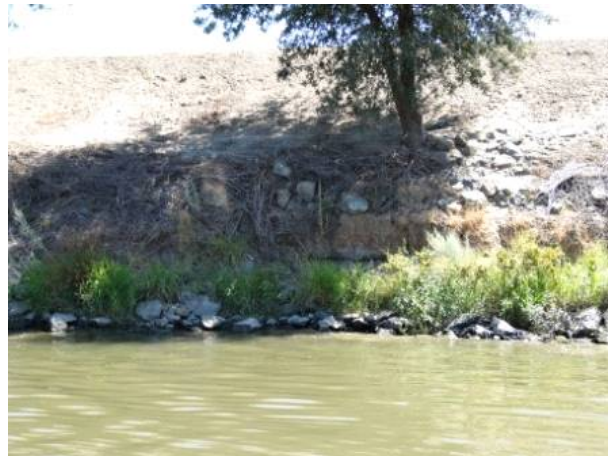
Levee Mile Report Line	3
Start Levee Mile	0.10
End Levee Mile	0.11
Location	Water Side
Category	Supplemental
Item	DWR Erosion Survey

LMR No.	Levee Mile		Category	Item	* Location	+ Rating	Action/Comment	GPS Latitude/Longitude		Issue No.
	Start	End						Start	End	
1	-0.03	0.07	Supplemental	DWR Erosion Survey	WS	U Ma	Inspector Comments: 08/13/2013: No significant change observed. 08/07/2012: The site has been visited by boat survey. No significant change observed 08/23/2011: Site is at the upstream of a drainage ditch. [2013 Site ID:RD2062U03RM29.93]	37.809673 ° -121.390321 °	37.809673 ° -121.390321 °	1 Y
DWR ID:										
2	0.08	0.08	Earthen Levee	Trim / Thin Trees	WS	N Ma	T5 : Tree stumps.	37.809727 ° -121.389100 °	37.809727 ° -121.389100 °	3 Y
DWR ID: DWR_RD2062_03_f_2012_3										
3	0.10	0.11	Supplemental	DWR Erosion Survey	WS	U Ma	Inspector Comments: 08/13/2013: No significant change observed. 08/07/2012: The site has been visited by boat survey. No significant change observed 08/23/2011: Hard to view the erosion because of the dense vegetation and trees on site. The site is under the bush, close to the tree. [2013 Site ID:RD2062U03RM30.02]	37.810052 ° -121.388847 °	37.810052 ° -121.388847 °	2 Y

Front view of the site.

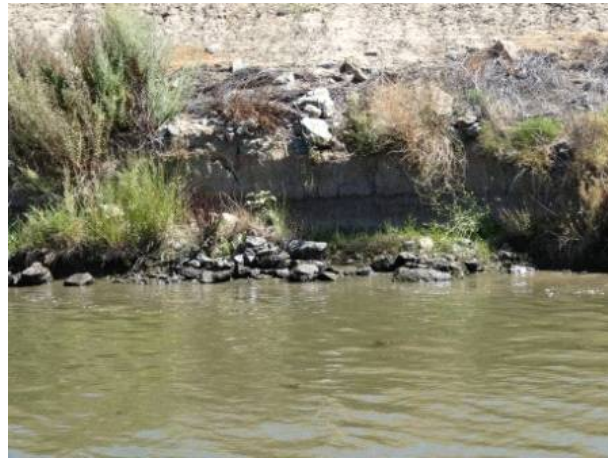
Front view of the erosion.

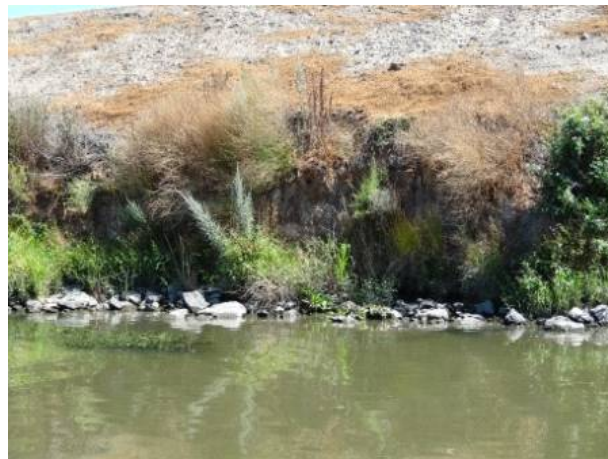
Levee Mile Report Line	6
Start Levee Mile	0.23
End Levee Mile	0.32
Location	Water Side
Category	Supplemental
Item	DWR Erosion Survey

LMR No.	Levee Mile		Category	Item	Location *	Rating ** +	Action/Comment	GPS Latitude/Longitude		Issue No. Photo
	Start	End						Start	End	
6	0.23	0.32	Supplemental	DWR Erosion Survey	WS	U Ma	Inspector Comments: 08/13/2013: A new pocket erosion at the upper levee slope has been found directly above a large tree. The erosion might have been caused by internal pipe leakage or surface runoff. 08/07/2012: The site has been visited by boat survey. No significant change observed 08/23/2011: No significant changes observed on site. Dense vegetation is visible along the water line. 09/07/2010: No significant changes observed on site. Much of the upper slope was recently cleared of vegetation by spraying. 4- to 6-foot vertical scarp and pocket erosions are lined along a span of 475 feet. In some sections, the vertical scarp encroaches into the levee prism. There is a lack of berm along this reach, exposing the levee slope to high flow velocities during normal and flood events. 08/06/2010: Recommended as local maintenance issue, per CLRO. 03/09/2010: As discussed with Michael Moncrief of MBK Engineers, the site will be 'addressed' later this year. 09/29/2009: No major change observed since last visit; pocket erosion and a vertical scarp forming; this site was combined with Site RM30.13 and 30.02 with a combined total erosion length of 475 feet; recommended as annual assessment and monitoring of site, per CLRO CES Evaluation 2008 Report; previously rated "M". 11/05/2008: Top of vertical scarp has rip rap that appears to be sliding; rodent holes; existing toe rip rap. [2013 Site ID:RD2062U03RM30.19]	37.810609 ° -121.385879 °	37.810609 ° -121.385879 °	5 Y

Close view of the pocket erosion.

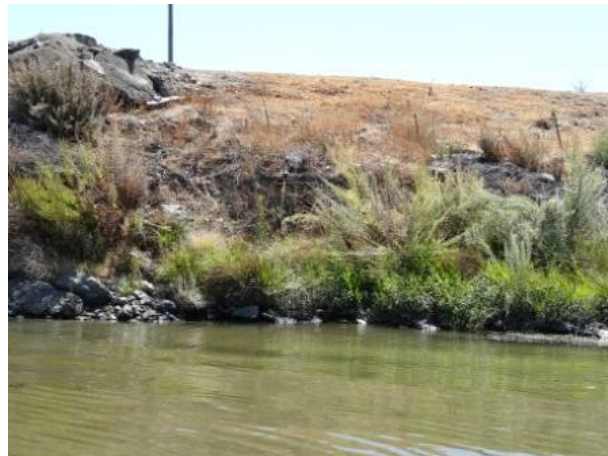
Levee Mile Report Line	7
Start Levee Mile	0.35
End Levee Mile	0.35
Location	Water Side
Category	Supplemental
Item	DWR Erosion Survey

7	0.35	0.35	Supplemental	DWR Erosion Survey	WS	M Ma	Inspector Comments: 08/13/2013: No significant change observed. 08/07/2012: The site has been visited by boat survey. No significant change observed 08/23/2011: The site is right at the downstream of a river bend. [2013 Site ID:RD2062U03RM30.27]	37.811281 ° -121.384461 °	37.811281 ° -121.384461 °	8 Y
8	0.52	0.52	Earthen Levee	Encroachments	WSA/W	PI : Pipe Ma	Inspector Comments: Water intake pump station; 16" pipe	37.812687 ° -121.382800 °	37.812687 ° -121.382800 °	52 Y

Upstream view of the erosion.

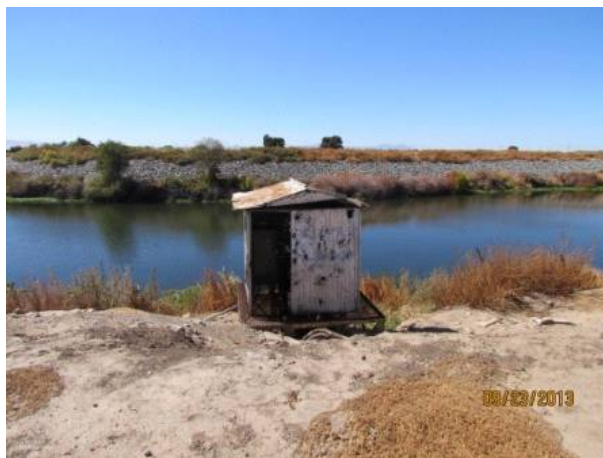
View of the pump house on the waterside levee slope.

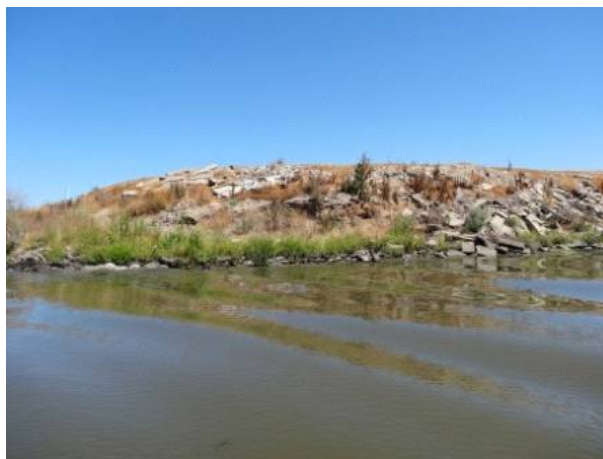
Levee Mile Report Line	9
Start Levee Mile	0.56
End Levee Mile	0.57
Location	Water Side
Category	Supplemental
Item	DWR Erosion Survey

LMR No.	Levee Mile		Category	Item	Location	Rating	Action/Comment	GPS Latitude/Longitude		Issue No.
	Start	End						Start	End	
9	0.56	0.57	Supplemental	DWR Erosion Survey	WS	M Ma	<p>Inspector Comments: 08/13/2013: No significant change observed.</p> <p>08/07/2012: The site has been visited by boat survey. No significant change observed.</p> <p>08/23/2011: No significant changes observed on site.</p> <p>09/07/2010: No significant changes observed on site.</p> <p>Much of the placed rip rap revetment has slid. It is no longer adequately protecting the slope.</p> <p>08/06/2010: Recommended as local maintenance issue, per CLRO Report.</p> <p>03/09/2010: As discussed with Michael Moncrief of MBK, site will be 'addressed' this year.</p> <p>09/29/2009: No major change observed since last visit; a section of the rip rap has slipped, exposing a levee section that has eroded; recommended as local maintenance issue, per CLRO CES Evaluation 2008 Report; Site # is the same as RM30.43,LM0.63; previously rated "U".</p> <p>11/05/2008: Site is located inside of a bend; scarp looks to be into the levee prism; piles of concrete chunks placed on the slope, with some of them already starting to slide.</p> <p>[2013 Site ID:RD2062U03RM30.43]</p>	37.813070 ° -121.383100 °	37.813070 ° -121.383100 °	9 Y

Close view of the site.

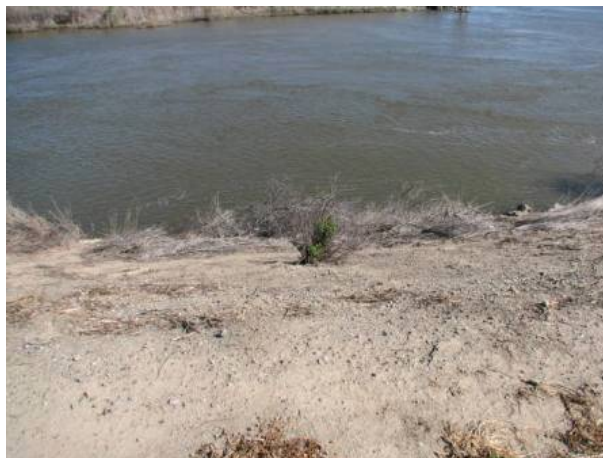
Levee Mile Report Line	10
Start Levee Mile	0.61
End Levee Mile	0.61
Location	Water Side
Category	Earthen Levee
Item	Trim / Thin Trees

10	0.61	0.61	Earthen Levee	Trim / Thin Trees	WS	N Ma	<p>T5 : Tree stumps.</p> <p>Inspector Comments: Stump in slope.</p>	37.813570 ° -121.382094 °	37.813570 ° -121.382094 °	10 Y
11	0.65	0.65	Earthen Levee	Trim / Thin Trees	WS	N Ma	<p>T5 : Tree stumps.</p> <p>Inspector Comments: 2 stumps on waterside slope.</p>	37.813894 ° -121.381680 °	37.813894 ° -121.381680 °	12 Y
12	0.82	0.82	Earthen Levee	Erosion / Bank Caving	WS	M Ma	<p>E2 : Schedule repair of erosion site prior to the next inspection.</p> <p>Inspector Comments: Cracking developing along the waterside levee hinge.</p>	37.816315 ° -121.381587 °	37.816315 ° -121.381587 °	11 Y

05/11/2011 Stump in slope, new growth in center of photo is at the location of the stump.

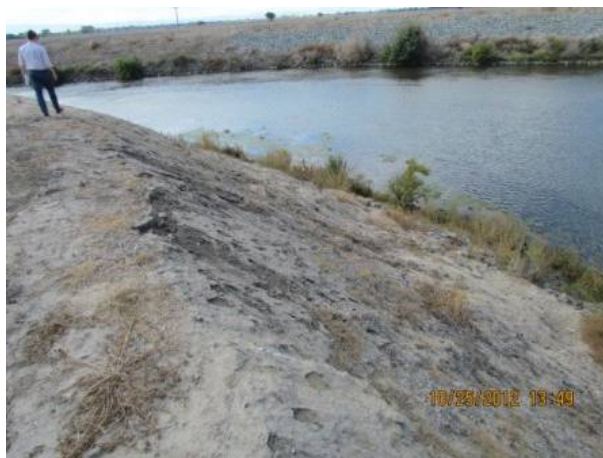
View of slope erosion from foot traffic.

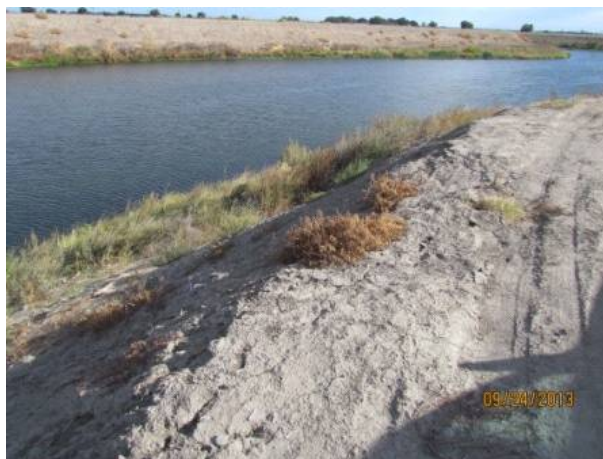
Levee Mile Report Line	12
Start Levee Mile	0.82
End Levee Mile	0.82
Location	Water Side
Category	Earthen Levee
Item	Erosion / Bank Caving

View of cracking at waterside levee hinge.

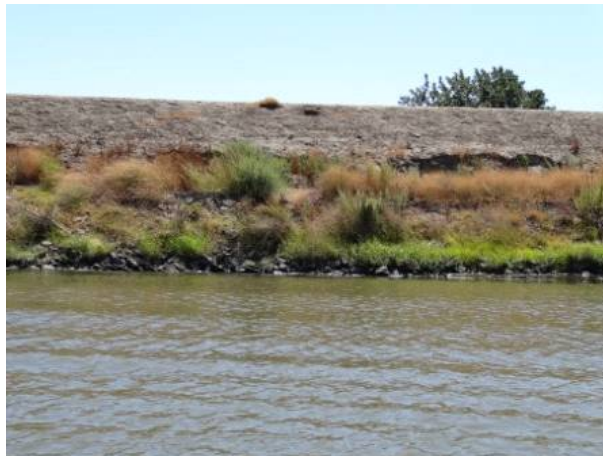
Levee Mile Report Line	13
Start Levee Mile	1.20
End Levee Mile	1.21
Location	Water Side
Category	Supplemental
Item	DWR Erosion Survey

LMR No.	Levee Mile		Category	Item	Location*	Rating** +	Action/Comment	GPS Latitude/Longitude		Issue No.
	Start	End						Start	End	Photo
13	1.20	1.21	Supplemental	DWR Erosion Survey	WS	U Ma	Inspector Comments: 08/13/2013: No significant change observed. 08/07/2012: The site has been visited by boat survey. No significant change observed 08/23/2011: No significant changes observed on site. 09/07/2010: No significant changes observed on site. Much of the seasonal grass along the slope was cleared. Site consists of an existing scalloped erosion approximately 30 feet long by 5 feet wide at its widest opening. The lateral crack is extended outwards along the middle slope. There is a 1 to 2 feet of differential settlement that could further develop into a shallow slide. 08/06/2010: Recommended as local maintenance issue, per CLRO. 03/09/2010: As discussed with Michael Moncrief of MBK Engineer, site will be 'addressed' this year. 09/28/2009: No major change observed; section of rip rap has slipped, creating a terraced effect; dense vegetation growth; recommended as a local maintenance issue, per CLRO CES Evaluation 2008 Report; Site # is the same as RM31.12,LM1.25; previously rated "U". 09/14/2006: 1-2' into prism. [2013 Site ID:RD2062U03RM31.12]	37.819290 ° -121.378880 °	37.819290 ° -121.378880 °	13 Y

Front view of the site. Existing scalloped erosion is immediately downstream of rip rap section.

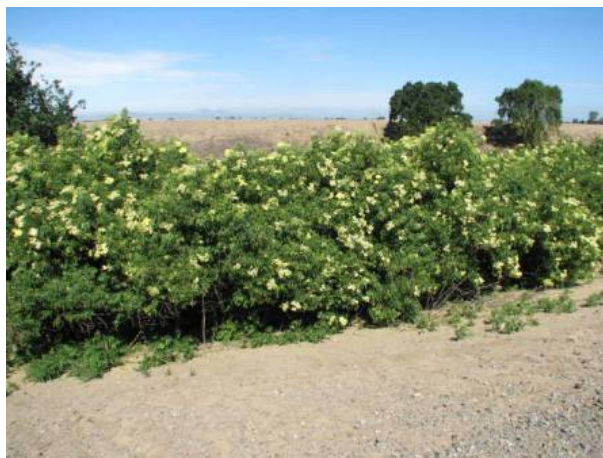
05/11/2011 Elderberry bush on water side slope.

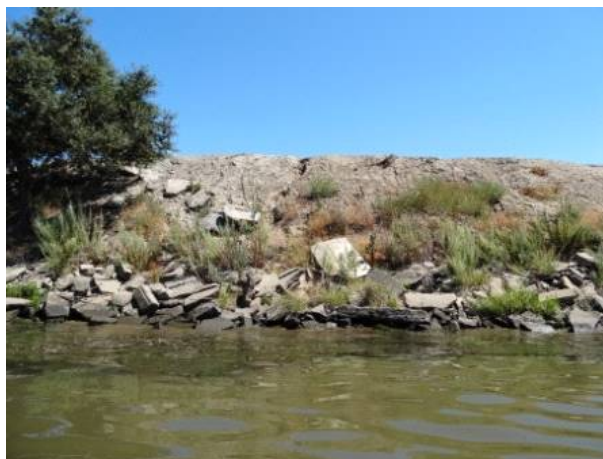
Levee Mile Report Line	15
Start Levee Mile	1.42
End Levee Mile	1.43
Location	Water Side
Category	Supplemental
Item	DWR Erosion Survey

LMR No.	Levee Mile		Category	Item	Location	Rating	Action/Comment	GPS Latitude/Longitude		Issue No. Photo
	Start	End						Start	End	
15	1.42	1.43	Supplemental	DWR Erosion Survey	WS	U Ma	Inspector Comments: 08/13/2013: No significant change observed. 08/07/2012: The site has been visited by boat survey. No significant change observed 08/23/2011: No significant changes observed on site. 09/07/2010: No significant changes observed on site. There is a small- to medium sized Oak tree on the mid-slope just above rip rap. Some of the rip rap has collapsed, creating a pocket erosion just above the existing toe rip rap and upstream of the Oak tree. 08/06/2010: Recommended as local maintenance issue, per CLRO. 03/09/2010: As discussed with Michael Moncrief of MBK Engineer, site will be 'addressed' in 2010. 09/29/2009: No major change since last visit; sliding of the rip rap at the base of the lone tree; there is noticeable man-made trail and foot traffic extending from the crown to the toe; much of the broken concrete used as temporary rip rap has slid, exposing portion of the bare levee slope; recommended as local maintenance issue, per CLRO CES Evaluation 2008 Report; Site # is the same as RM31.3, LM1.45; previously rated "M". 11/05/2008: Portion of rip rap collapsing. 09/14/2006: Portion of rip rap along the slope has collapsed; exposed levee section is starting to erode, exposing roots from the nearby tree. [2013 Site ID:RD2062U03RM31.28]	37.821380 ° -121.376900 °	37.821380 ° -121.376900 °	20 Y

Front view of the site.

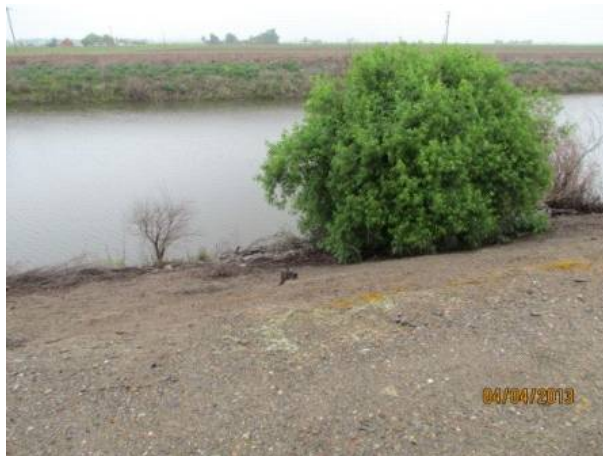
Levee Mile Report Line	17
Start Levee Mile	1.67
End Levee Mile	1.67
Location	Water Side
Category	Earthen Levee
Item	Trim / Thin Trees

View of the tree stump on the waterside levee slope.

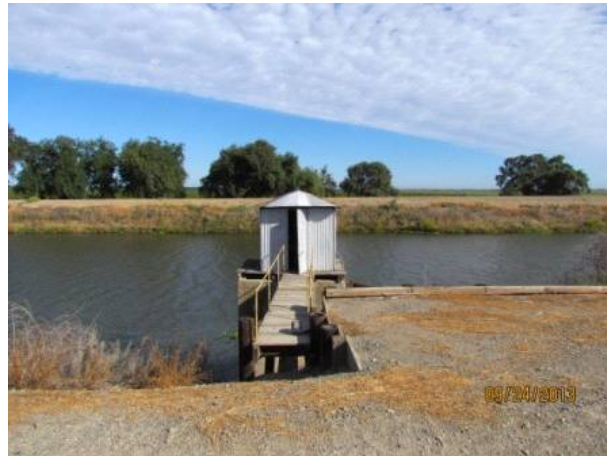
View of the pump house on the waterside levee slope.

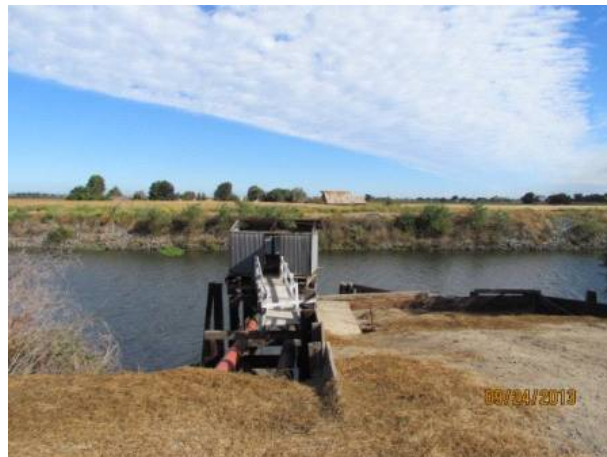
Levee Mile Report Line	20
Start Levee Mile	2.80
End Levee Mile	2.80
Location	Water Side
Category	Earthen Levee
Item	Encroachments

View of the pump house on the waterside levee slope.

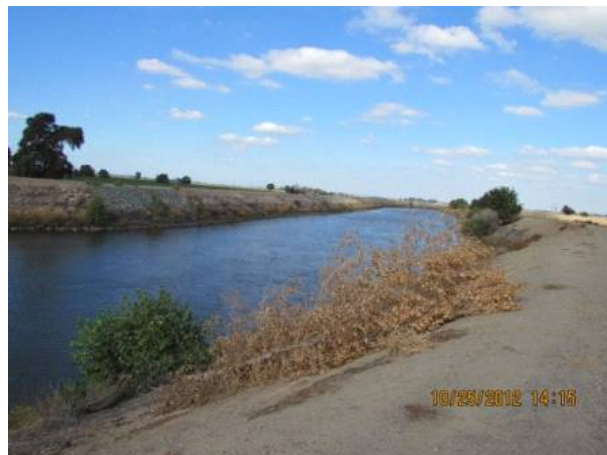
Levee Mile Report Line	26
Start Levee Mile	3.80
End Levee Mile	3.80
Location	Water Side
Category	Earthen Levee
Item	Trim / Thin Trees

View of damaged tree by beaver on waterside slope.

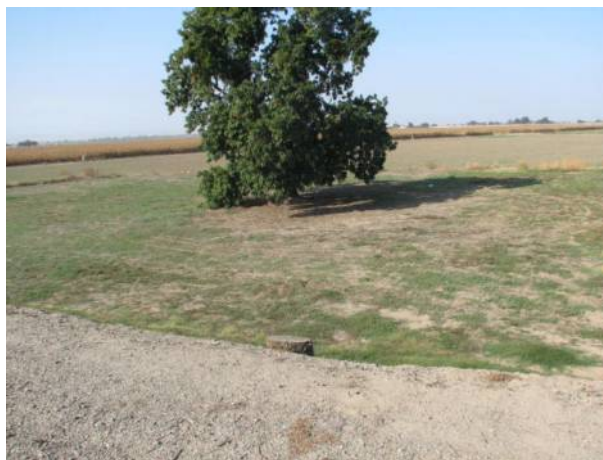
10/21/2011 Photo taken the next day. Stump can be seen in the lower center of the photo.

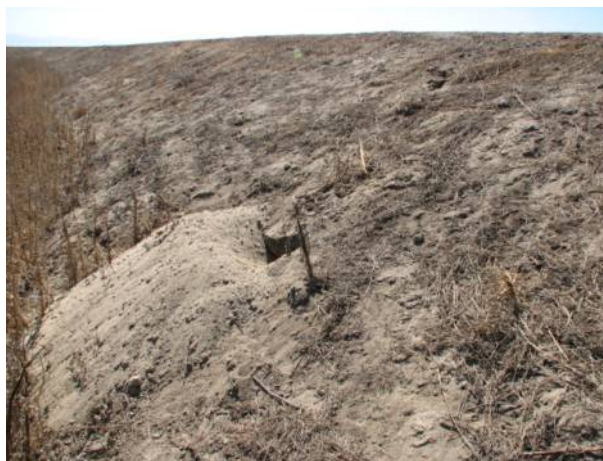
Levee Mile Report Line	30
Start Levee Mile	4.83
End Levee Mile	4.83
Location	Water Side
Category	Earthen Levee
Item	Animal Control

Animal burrow on levee slope.

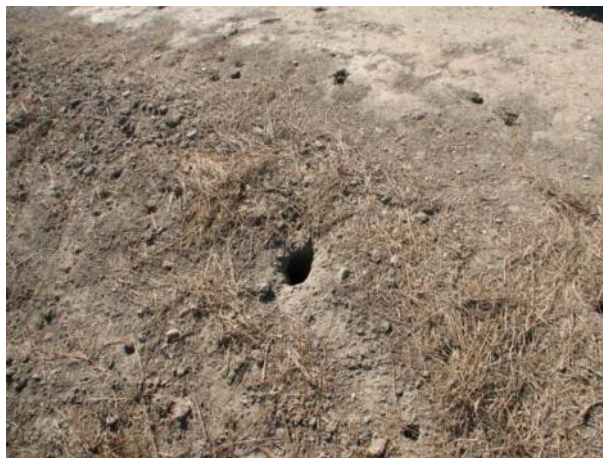
Levee Mile Report Line	30
Start Levee Mile	4.83
End Levee Mile	4.83
Location	Water Side
Category	Earthen Levee
Item	Animal Control

Animal burrows on levee slope.

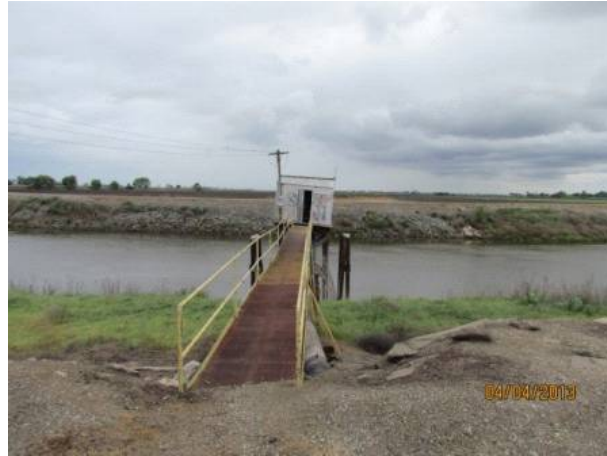
View of the pipe penetrating the waterside levee slope.
